# Major Pit Wall Failure

Presented by Cres Bulger (Inspector Of Mines)

**Three coal mine workers were seriously harmed, and unable to return to work for an extended period of time. An O&K RH 340 Excavator and a Komatsu 830E Rear Dump were also extensively damaged in the incident.**

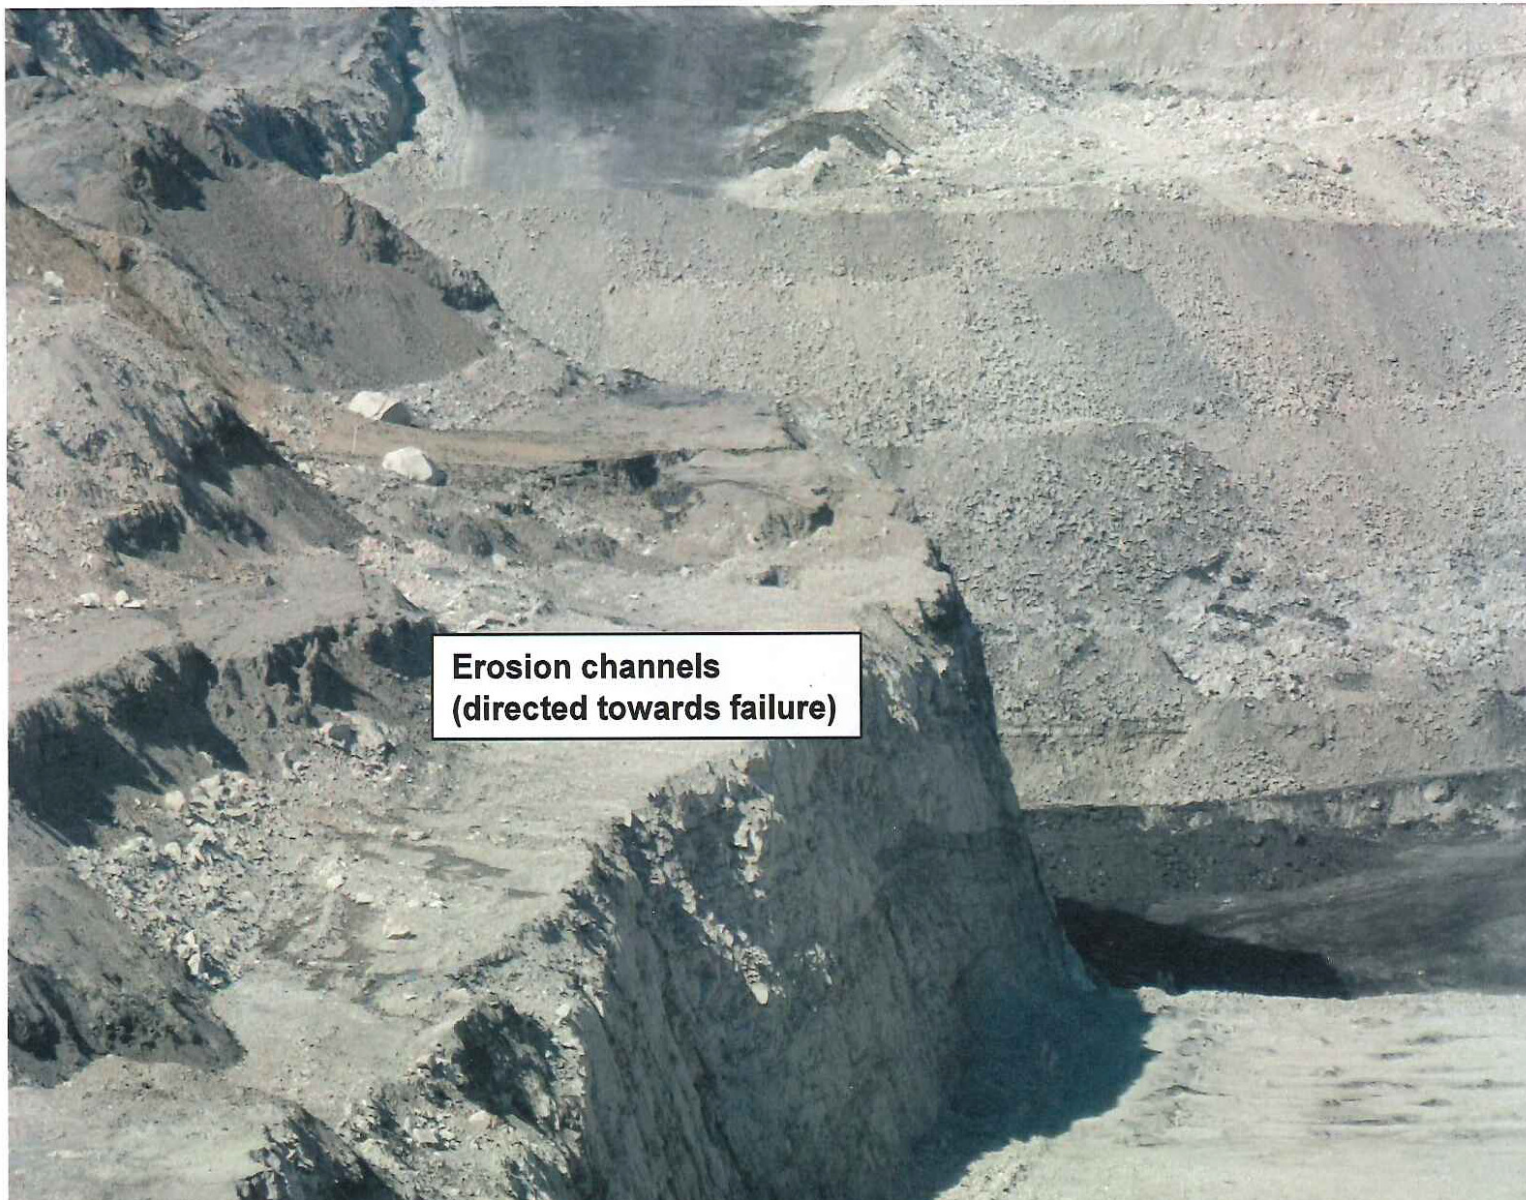
**Erosion channels  
(directed towards failure)**
